# SOLITARY ISLANDS SHIPWRECKS SURVEY

14-16 February 2000  
and  
14 August 2000

## CONSERVATION MANAGEMENT PLAN

*Buster* (1884-1893)  
*Lady of Lorn* (1877-1889)  
ss *Wyong* (1884-1901)  
4 anchors on public display

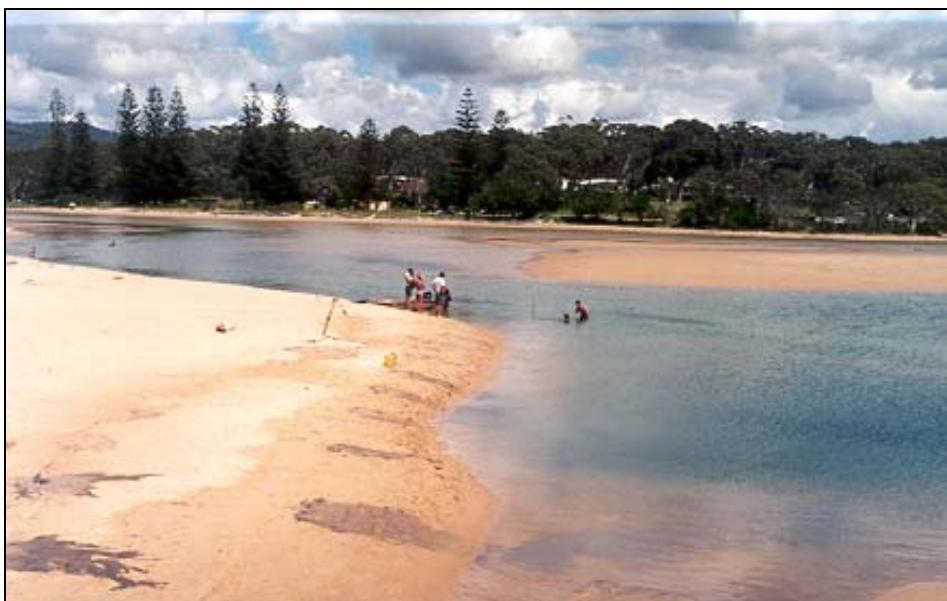
The buried section of timber had been occasionally sighted within Moonee Creek following storm activity. It is evident that the profile of Moonee Creek and its course changes with flood or heavy storm activity. At times this has led to the exposure of a limited section of timber hull. Local residents helped to direct the survey team to the seaward bank of the creek where they had last observed the remains. This is at a point near to the mouth of Moonee Creek from where it turns and breaks out over Moonee Beach to the sea.

Figure 14: *View of the survey operation at Moonee Creek.*  
Photo: David Nutley.
